# Streamline Series VNA & PC setup procedure and its Troubleshooting tips

**Keysight Technologies**  
**30-Mar-2026**

Streamline Series VNA A model:

Streamline Series VNA B model:

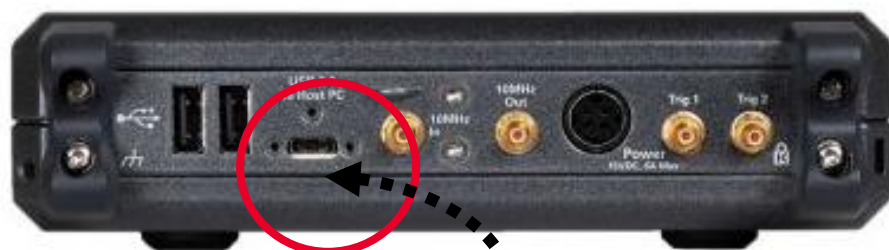
P50xxA/P93xxA rear panel

USB3.0 port x1  
(USB Type-C)

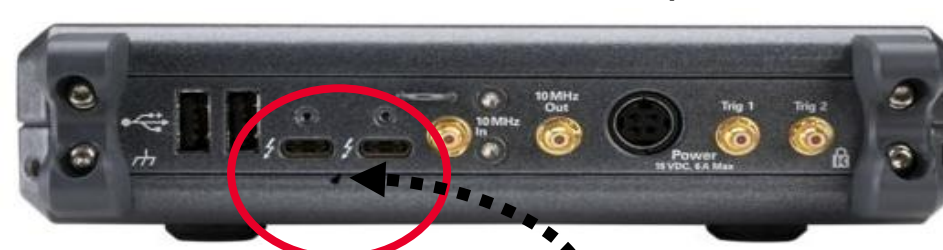
P50xxB/P93xxB rear panel

Thunderbolt 3 port x2  
(USB Type-C)

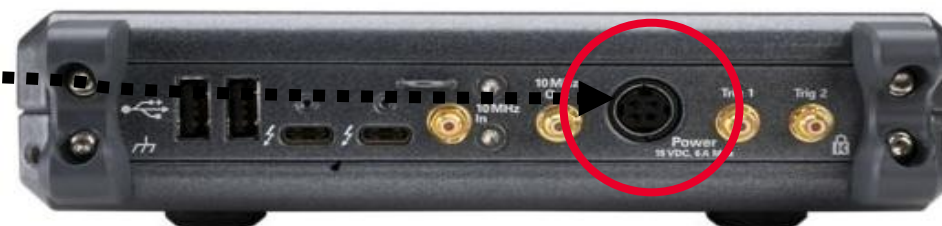
Streamline Series VNA (2-port model)<sup>2</sup> rear panel

1. Make sure to connect the AC adapter included in the Streamline Series VNA.
2. 2-port model requires minimum 90W adapter (KPN: 0950-6128). 150W adapter (KPN: 0950-6166) can work, too.

| Symptom | Possible root cause | Solution |
|---|---|---|
| #3-3-1-2<br>Blinking red | Power adapter does not supply enough power | <div>① Check if proper power adapter is used (See <a href="#">3-2</a>).<br/>If KPN 0950-6128 is used to Streamline Series VNA 4-/6- port model, replace it with KPN 0950-6166.</div> <div>② Retry powering on the VNA.<br/>If the symptom still occurs, return it to Keysight for repair.</div> |

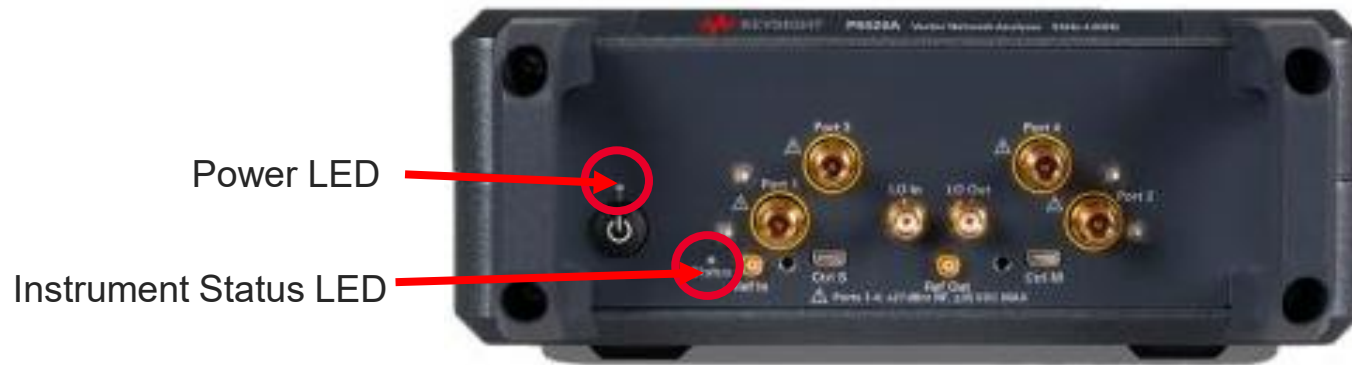
### 3-3. Power on Streamline Series VNA, then confirm if the Power LED is green

If Power LED is not green, go to [Troubleshooting tips 3-3](#)

| Symptom | Possible root cause | Solution |
|---|---|---|
| #3-3-1-1<br>Not glowing amber when power adapter is connected to VNA | Power adapter or power line in the VNA is broken. | Return it to Keysight for repair |
| #3-3-1-3<br>Glowing red | PC does not recognize the VNA | <div>① Check the power on sequence.<br/>1.Connect the cable between PC and the VNA (See <a href="#">3-1</a>)<br/>2. Power on the VNA (See <a href="#">3-2</a>, <a href="#">3-3</a>)<br/>3. Power on the PC (3-4)</div> <div>② If the symptom still occurs, return it to Keysight for repair.</div> |

| Symptom | Possible root cause | Solution |
|---|---|---|
| <b>#3-3-1-4</b><br>Once glowing green for a few seconds, then shutdown automatically<br>Impacted model: 2-port VNA only | VNA firmware version A.15.60.05 or newer has a function to shutdown automatically when in-rush voltage drop event is detected. [This is intended behavior] | ① Check if VNA firmware version A.15.55.14 or newer.<br>If VNA firmware version is A.15.60.05 or newer, the firmware has a function to shutdown automatically when in-rush voltage drop event is detected.<br>② Retry powering on the VNA.<br>If the symptom still occurs, return it to Keysight for repair. |
| <b>#3-3-1-5</b><br>Glowing blue | Chassis FPGA update failed. | Return it to Keysight for repair |

| Symptom | Possible root cause | Solution |
|---|---|---|
| #3-3-2-1<br>Glowing amber | Power is ON, but firmware is not running. | <ul style="list-style-type: none"><li>① Check if VNA firmware is working correctly.</li><li>② If not, go to <a href="#">Troubleshooting tips2-5</a></li><li>③ Check if the cable between Streamline Series VNA and PC is connected correctly</li><li>④ If not, replace the cable</li><li>⑤ If the symptom still occurs, return it to Keysight for repair.</li></ul> |
| #3-3-2-2<br>Glowing red | PC battery is not maintained in a fully charged condition.<br>Or<br>A hardware error has occurred, or the VNA firmware is not installed or corrupted in the PC. | <ul style="list-style-type: none"><li>① Make sure AC/DC adapter for the PC is connected.</li><li>② Check if VNA firmware is installed correctly.</li><li>③ If not, go to <a href="#">Troubleshooting tips 2-5</a></li><li>④ If the symptom still occurs, check if Keysight IO Libraries Suites is installed correctly.</li><li>⑤ If not, go to <a href="#">Troubleshooting tips 2-4</a></li><li>⑥ If the symptom still occurs, return it to Keysight for repair.</li></ul> |

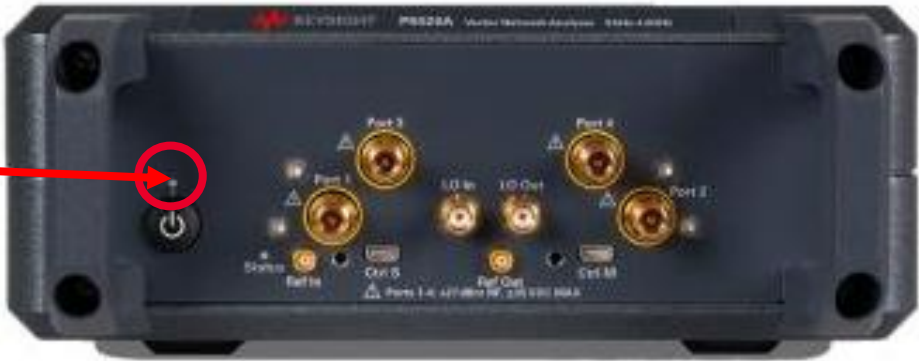
## 3-3-1. Power LED does not turn green

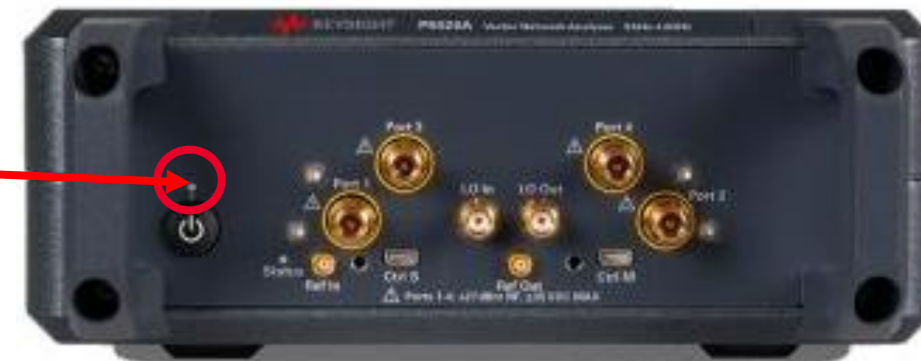
### 3-3-1. Power LED does not turn green

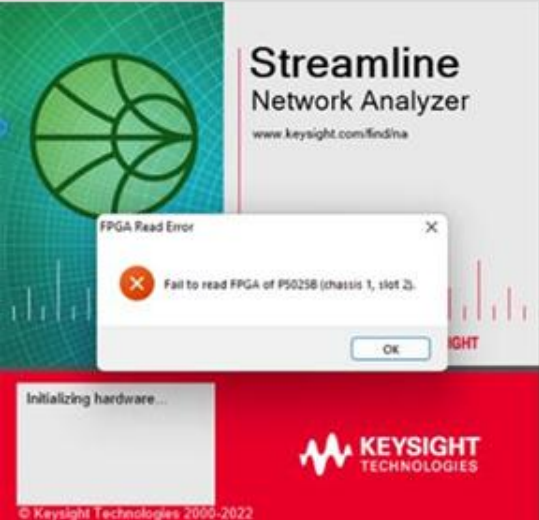
| Symptom | Possible root cause | Solution |
|---|---|---|
| <p>#3-10-1<br/>Fail to read FPGA of Pxxxxx (chassis x, slot x) is shown while Initializing hardware.</p> | <p>VNA firmware was not able to read FPGA on Analog Module</p> | <p>Go to <a href="#">Troubleshooting Tips #3-10-4</a></p> |

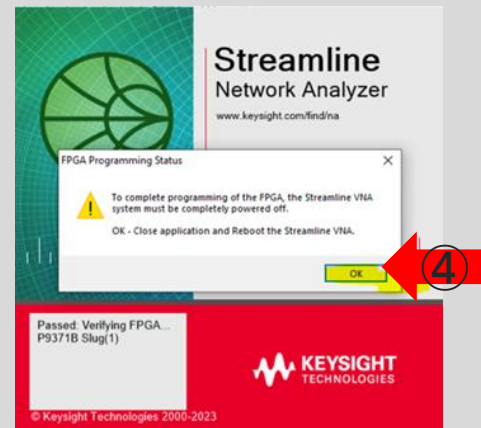
- ③ FPGA Programming Status pops up, then click Yes
- ④ FPGA Programming Status pops up and click OK, then launch Network Analyzer (See [3-10](#)).
- ⑤ The following message pops up, then click OK

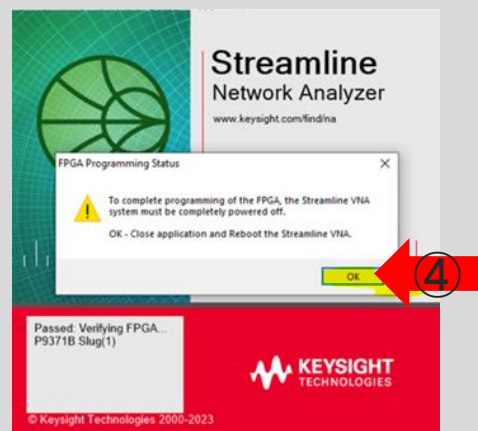
- ⑦ FPGA Programming Status pops up, then click Yes
- ⑧ FPGA Programming Status pops up and click OK, then launch Network Analyzer (See [3-10](#)).
- ⑨ The following message pops up, then click OK

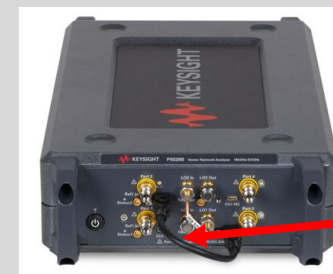
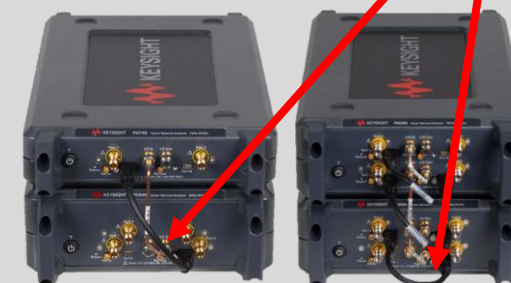
- ① Check if the control cable (Black) is connected properly. If the connection is missing or loosened, connect it and tighten it with the nuts as shown in the image below.
- ② If the symptom still occurs, replace the control cable.

nuts

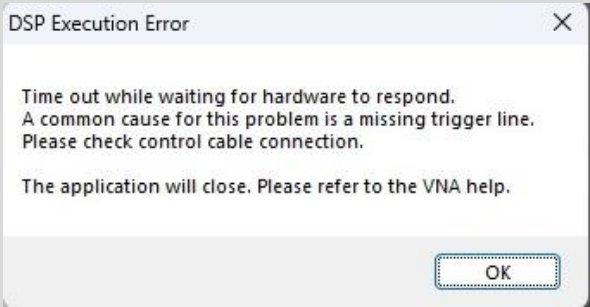
| Symptom | Possible root cause | Solution |
|---|---|---|
| <p>#3-10-10<br/>DSP Execution Error is shown</p> | <p>When DSP cannot receive the whole measurement data within the specified time, this error message is shown.</p> <p>There are some root causes found.</p> <p>#1. Command list size is bigger than FPGA processing capability</p> <p>#2. Contact failure due to</p> <ul style="list-style-type: none"><li>• PCIe connector lubricant</li><li>• control cable connector contamination</li><li>• control cable physical stress.</li><li>• solder residual on backplane board</li><li>• flux residual on backplane board</li></ul> | <p><b>Step1:</b> Check if control cable is connected properly. Go to <a href="#">Troubleshooting tips #3-10-5</a>.</p> <p><b>Step2:</b> If the symptom still occurs, try Workaround for #1.<br/>Workaround for #1<br/>If user measures multiple sweeps per channel, VNA firmware sends one command list per channel. Keysight workaround proposal is to send one command per sweep. Ask Keysight for more details.</p> <p><b>Step3:</b> If the symptom occurs continuously, return it to Keysight for repair.</p> |

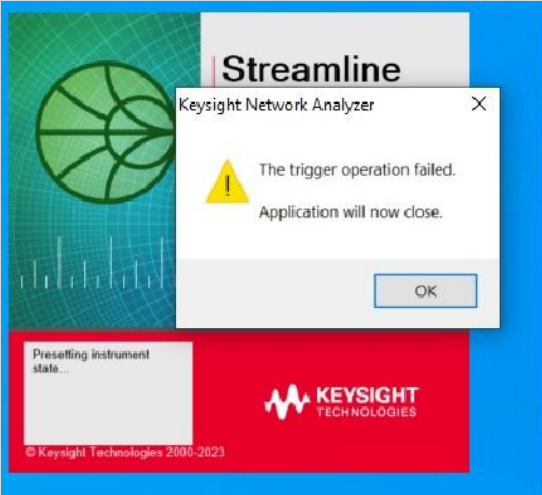
| Symptom | Possible root cause | Solution |
|---|---|---|
| <p>#3-10-15<br/>The trigger operation failed.<br/>Application will now close error is shown.</p> | <p>Interconnect cables for LO or control cable is not connected properly or broken.</p> | <p>Go to <a href="#">Troubleshooting tips #3-10-5</a></p> |

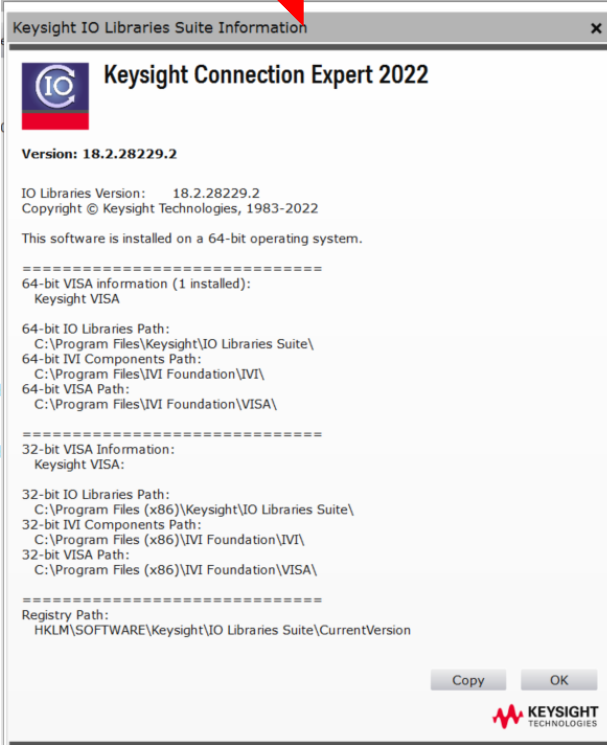
## Connection Expert information

1. Enter Keysight Connection Expert at Windows Search
2. Click Keysight Connection Expert
3. Take screenshot of Instruments and version information

Windows Search results for "Keysight Connection Expert" showing the app as the best match.

Keysight Connection Expert 2022 application window. The "Instruments" tab is selected, showing a list of instruments under "PXI/AXIe Chassis". The "LAN (TCPIP0)" instrument is highlighted. The "Detail for TCPIP0" panel on the right shows connection addresses and configuration options.

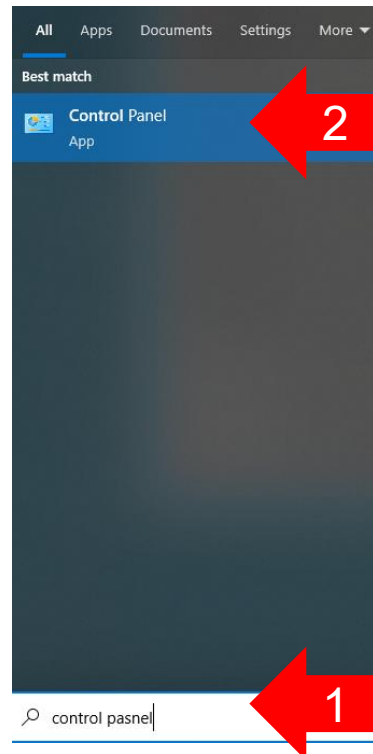
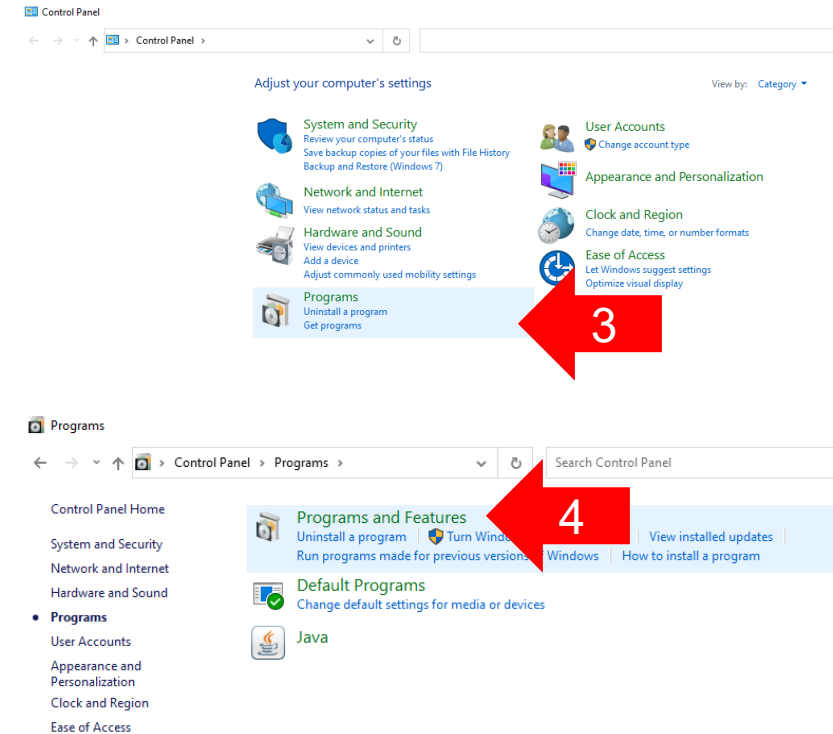
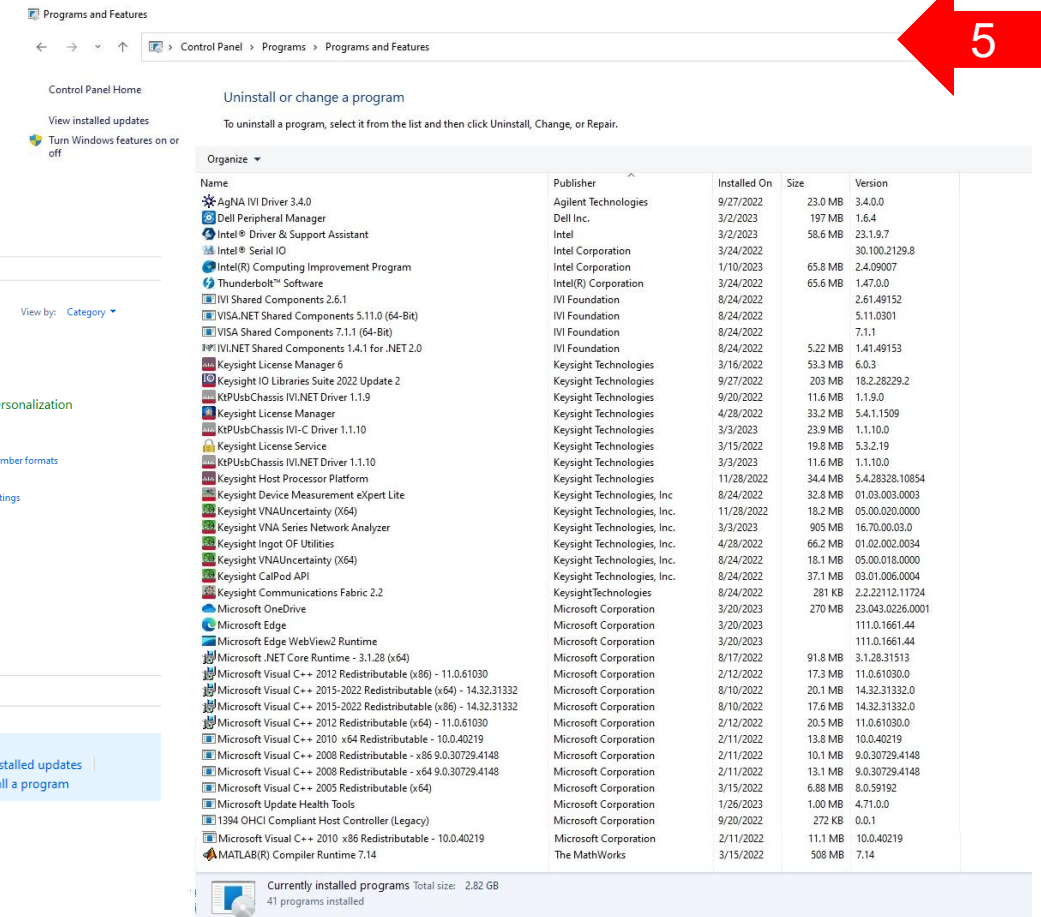
## Program and Features information

1. Enter Control Panel at Windows Search
2. Click Control Panel
3. Click Programs
4. Click Programs and Features
5. Take screenshot of programs and its version
